Figtree Place: A Case Study in Water Sensitive Urban Development (WSUD)

Peter J Coombes¹, John R Argue² and George Kuczera¹

Abstract

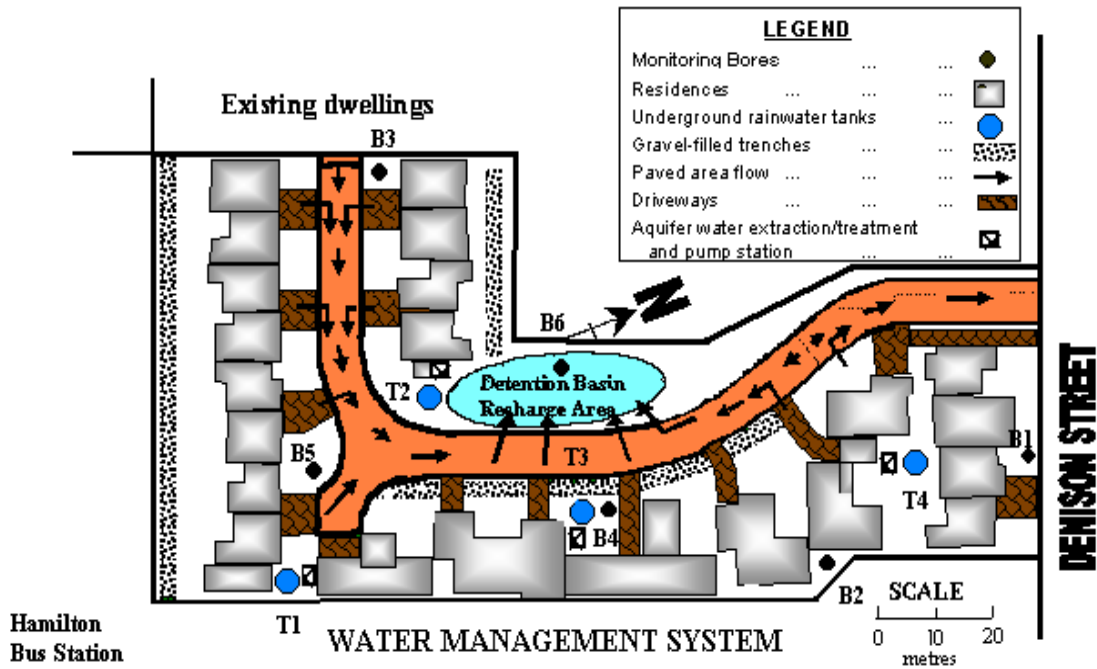
The plan of Figtree Place is shown in Figure 1. Its main features are :

Figure 1: General plan and water sensitive design elements of Figtree Place

Stormwater runoff from paths, lawns and gardens is directed into the Detention Basin via internal roadways (see Figures 1 and 2). The Detention Basin recharges the unconfined aquifer and provides an open space recreation area during dry spells. The Detention Basin has been sized to contain, without overflow, all storms up to and including the “once in 50 years” event.

Pumps with pressure vessels are situated in pump houses adjacent each raintank shown in Figure 1. Each pump house has a number of fail-safe systems. These include a second pump to operate in case of pump failure and a solenoid that switches water supply from tank water to mains supply if inadequate water pressure is detected, or electricity supply is interrupted or if a low water level is detected in a raintank.

An automated monitoring site was established at the pump house adjacent to the western tank (T2) shown in Figure 1. The site includes a data logger, tipping bucket rain gauge, pressure sensors, a water quality monitor and a refrigerated water quality sampler. The data logger controls all monitoring and recording processes.

Pressure sensors are used to measure water levels in the “first-flush” pit, in raintanks, and in groundwater bores (B1 to B6 in Figure 1). Pressure sensors are also placed in a small pit with a grate cover in the recharge basin to measure ponding depth, and in a slotted pipe standing upright within the gravel layer in the recharge trench to measure recession behaviour. The water quality monitor measures temperature, pH, DO, conductivity, turbidity and salinity of water stored in raintanks.

Although these construction errors were expected to significantly compromise tankwater quality, the sampling program was nevertheless commenced to assess this “worst-case” scenario. To further test the “worst-case” scenario the roof gutter system was not cleaned. Bacterial analysis of samples taken under these circumstances from raintanks at locations T1 to T4 shown in Figure 1 are summarised in Table 2.

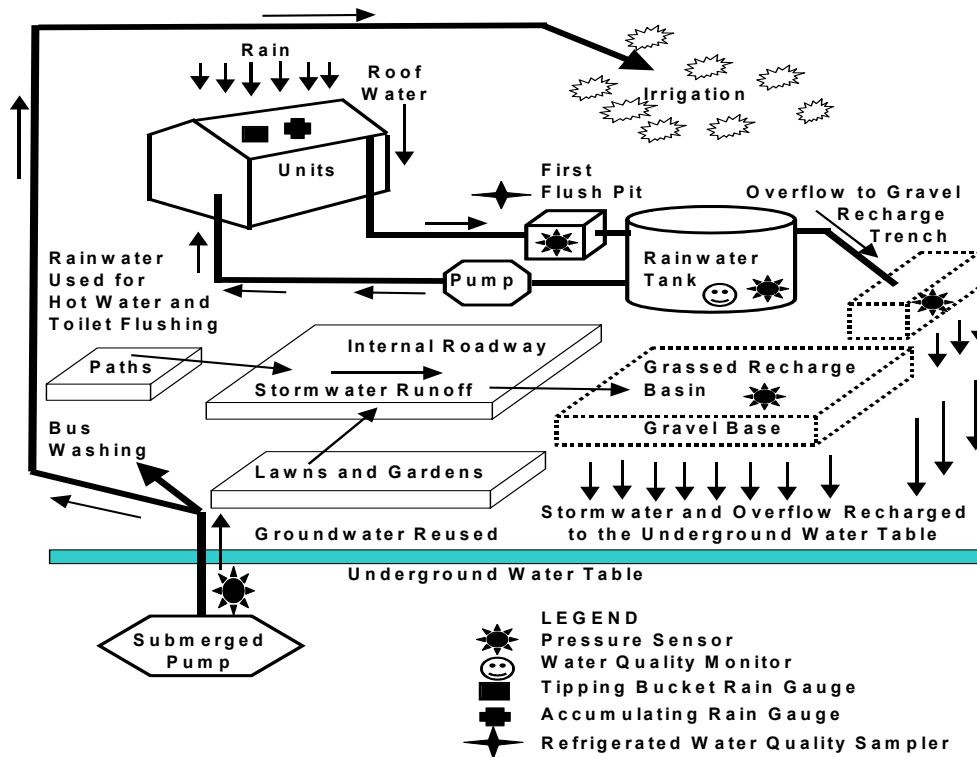
A schematic representation of the water sensitive features of Figtree Place is presented in Figure 2. Rainwater collected from roofs flows via stormwater pipes through a “first-flush” pit into each rainwater storage tank. Pumps with pressure cells supply rainwater from tanks for use in storage hot water systems and for toilet flushing. If a raintank’s capacity is exceeded, overflow is directed to a gravel trench which supplies recharge to the unconfined aquifer. Coombes et al. (1999) provide further design details for the site.

Figure 2: The Figtree Place Water Sensitive Design Concept

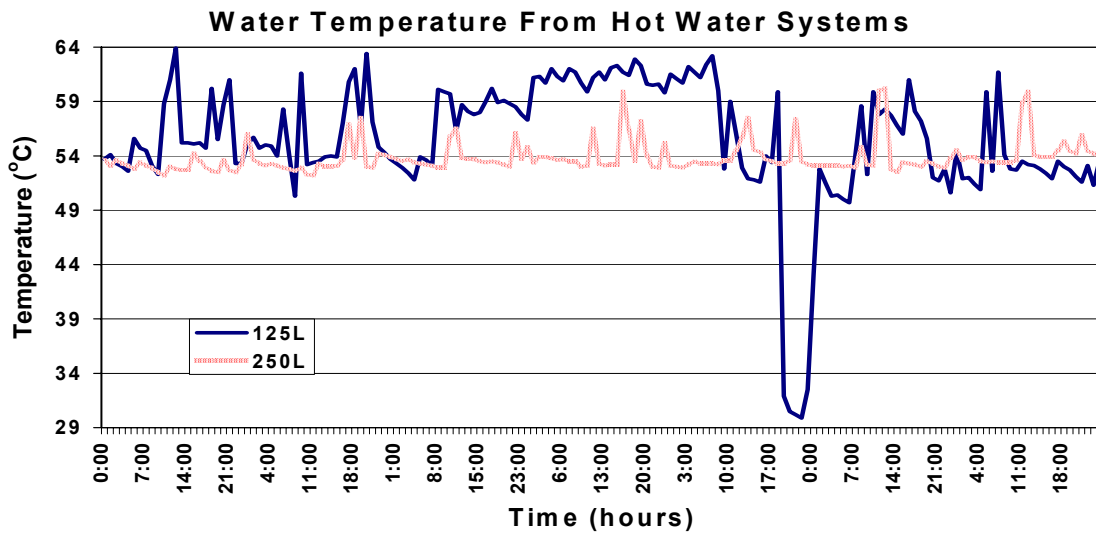
The efficacy of hot water systems to pasteurize rainwater depends on temperature and its duration. Figure 3 displays measured water temperatures over a period of one week for 2 electric hot water systems with 125 and 250 litre capacities and different usage patterns. These results are typical of the long term monitoring of hot water system performance.

Figure 3: Water temperatures for two different hot water systems over a period of a week

The 125 litre capacity system, set at 60° C supplied hot water at an “off-peak II” rate to a 2-person household. The “off-peak II” rate heats water from 6am to 8am and from 8pm to 10pm. The average operating temperature was found to be 56° C, the maximum temperature 64.5° C and the minimum 30° C. The low temperature of 30° C coincided with a full bath rather than the usual shower taken by one of the occupants.

The capacity and operating mode of the hot water system was insufficient to maintain the hot water supply within a temperature range which will ensure bacterial compliance with the Guidelines. Removal of the bath event from the data gives a minimum operating temperature of 50.1⁰ C.

The electric 250-litre capacity hot water system, set at 55⁰ C, supplies water at an off-peak II rate to a 4 person household at Figtree Place. However, unlike the 125-litre system, it has a secondary element that will heat water to the set temperature at any time of the day. This type of hot water system is installed in the units at Figtree Place. The average operating temperature was found to be 53.7⁰ C, the maximum temperature 60.2⁰ C and the minimum temperature 51.8⁰ C. This hot water system appears to have the capability to ensure reliable and acceptable water quality to the units.
